## Case 240 : Narrative

Case Vehicle (A): 2001 Ford
Type: F-350, 4x4, 4-door pickup
Driver: 28-year-old male
CDC: 12-FZEN-2

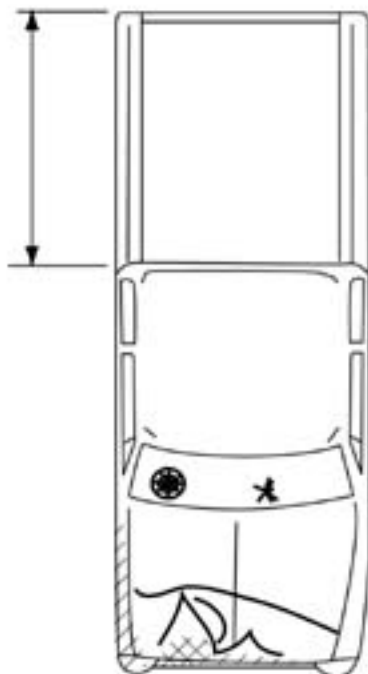
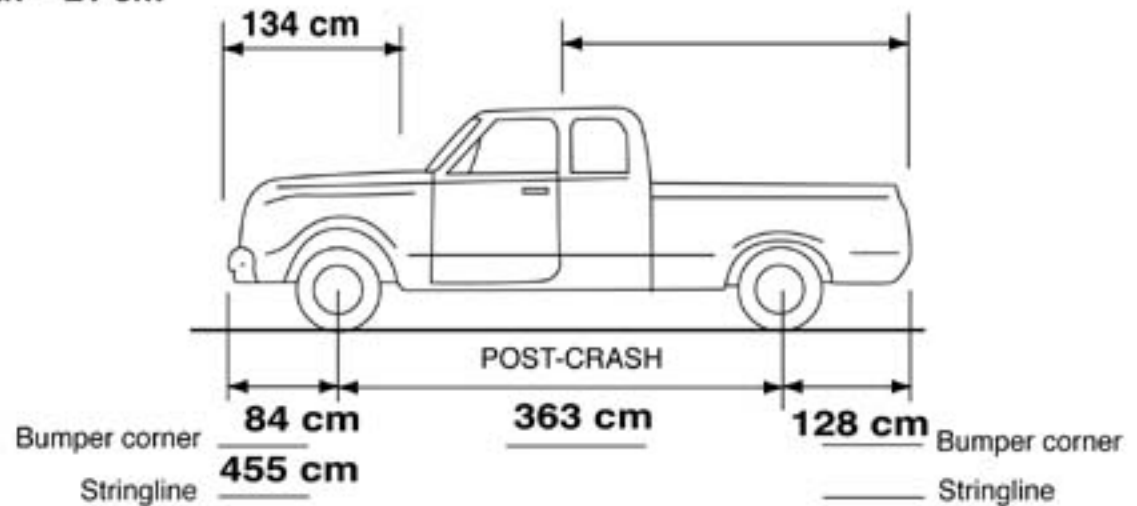
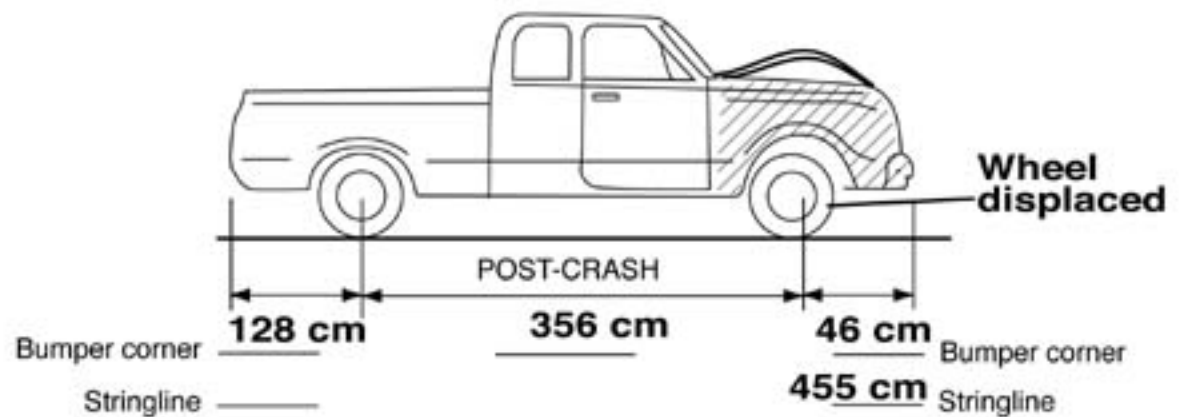
3 Damage to case vehicle (A) was moderate and was primarily to the right portion of the front end. The direct-damage length from the impact with the tree was 21 cm and began 50-cm inboard from the right-front bumper corner. The maximum crush to the bumper was 34 cm and occurred to the left of the right headlight assembly. The left wheelbase was extended 3 cm, and the right wheelbase was reduced 4 cm.

**Direct damage length = 21 cm**  
**Max crush = 34 cm**
